# MSi Testing & Engineering, Inc.

## *MSi Investigative Summary*

One (1) metal sample removed from a welded stainless steel pressure vessel was submitted to our laboratory for a metallurgical investigation. Reportedly, the ID surface of the sample exhibited a highly localized corrosion attack. It was also reported that the attack occurred in the form of dark, rounded recesses, and that the affected area was covered by an internal structural component. The ID surface of the sample was partially ground and dye-penetrant tested by maintenance personnel.

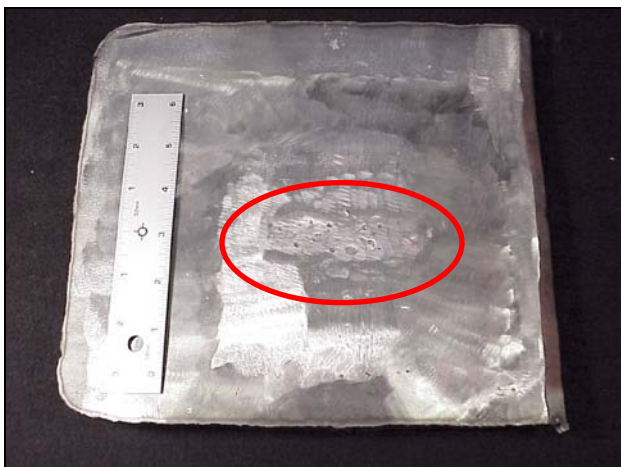
1. Visual and stereoscopic examination of the submitted vessel sample revealed an isle of pitting on the ID surface, with the pits measuring up to 1/4" wide and up to 1/8" deep (see Photos 1 – 2). The area contained evidence of grinding and dye-penetrant testing.

**Photo 1:** The vessel sample, as received. The pitted area is encircled by the red line.

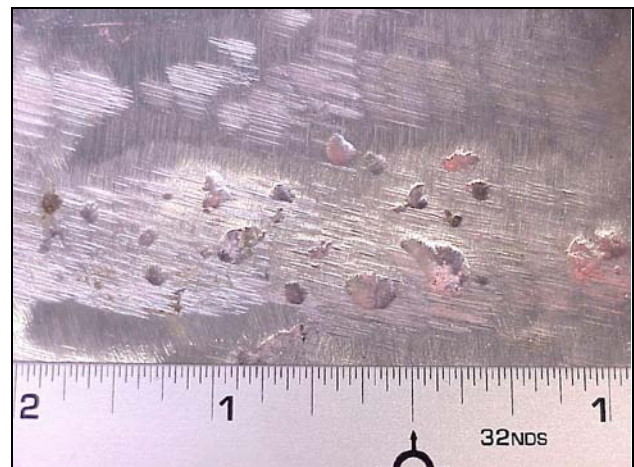
**Photo 2:** A close-up view of the pitted area.

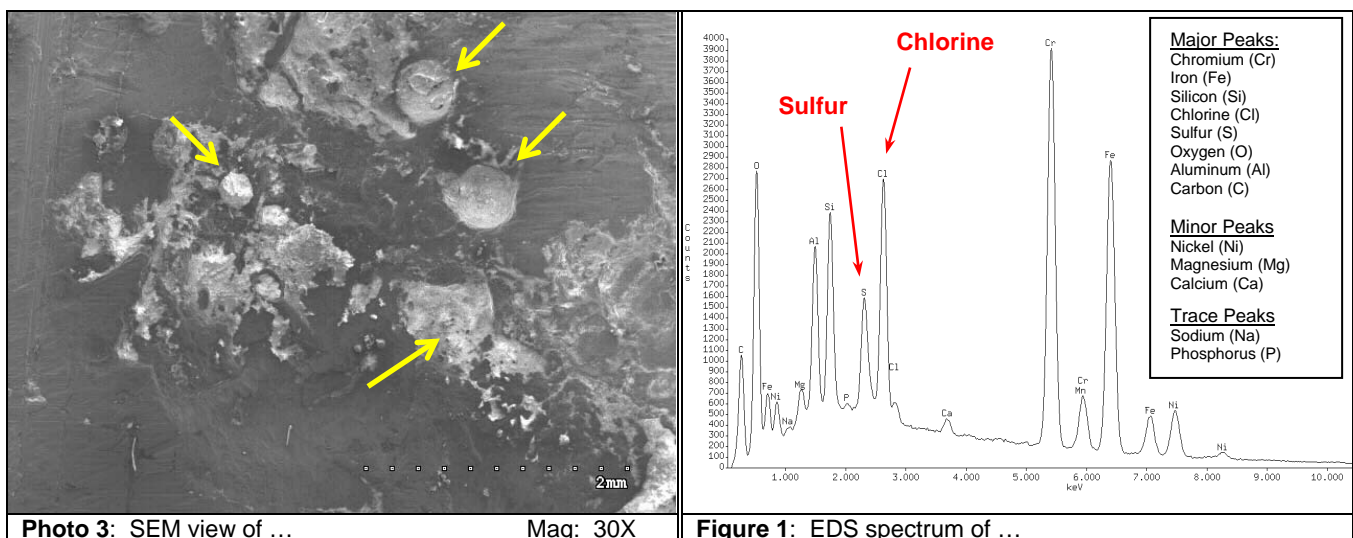
1. The surface grinding and the dye-penetrant testing performed by vessel maintenance personnel on the submitted sample caused removal of some corrosion attack evidence. However, SEM examination revealed remnants of nodular and flat deposit formations at the bottom of the pits (see Photos 3, arrows).

2. An EDS spectrum typical of the deposit formations is shown in Figure 1. Major, minor and trace spectral peaks are identified in the Figure inset. The observed elemental composition identified the deposits as a mix of iron, chromium and nickel oxides with sand and clay dust, some organic substances, and with appreciable amounts of chlorine and sulfur compounds (see arrows on Figure 1).

3. The observed heavy presence of sulfur in the analyzed deposits and the nodular deposit morphology implied that the primary factor responsible for the metal pitting was a MIC attack caused by the metabolic activity of either sulfur-oxidizing or sulfate-reducing bacteria.

4. The presence of chlorine peak implied an advanced stage of MIC and/or heavy extraneous contamination with chlorides.

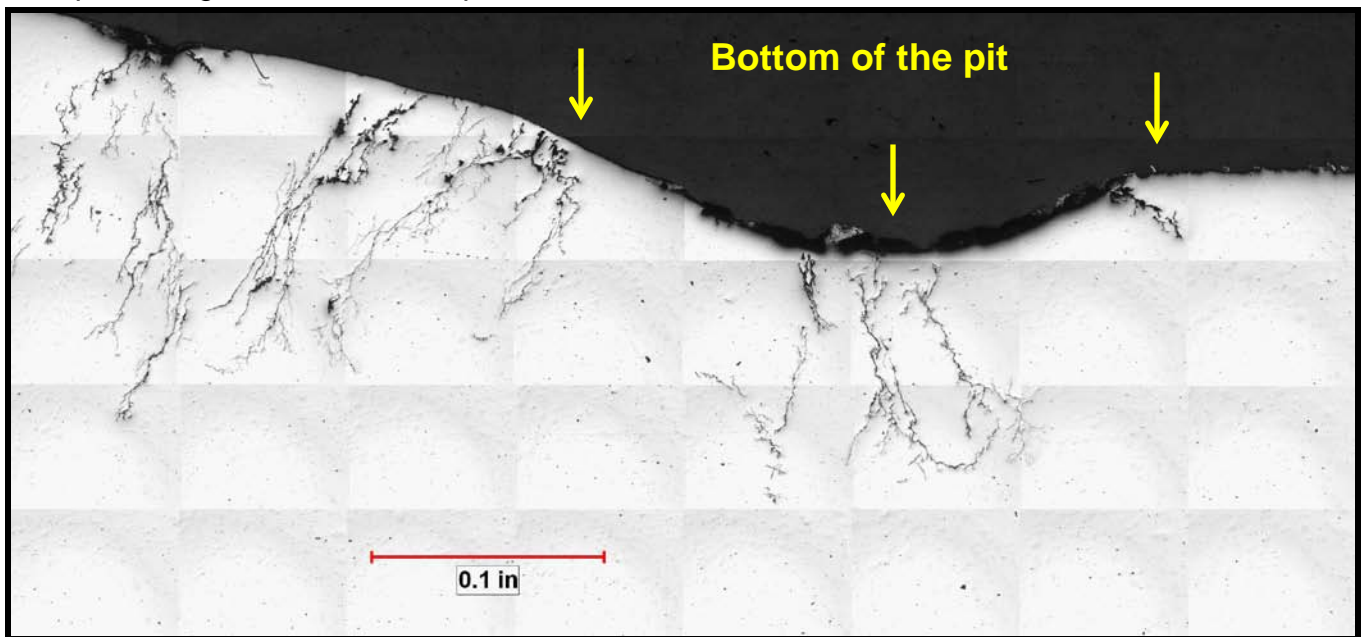
1. A section across a randomly-selected pit revealed a multitude of branching cracks emanating from the pit bottom into the base metal (see Photo 4).
2. At a higher magnification the cracking exhibited transgranular propagation (see Photo 5). The base metal in the underlying areas showed a uniform equiaxed austenitic microstructure with some twinning, typical of a 300-series stainless steel (see Photo 6).
3. The observed microstructural features are characteristic of a chloride-induced stress-corrosion cracking attack in 300-series stainless steel, and support the results of the preceding visual, stereoscopic and SEM/EDS examinations.

**Photo 4:** A stitched mosaic image of the pit profile, showing extensive cracking emanating from the bottom.

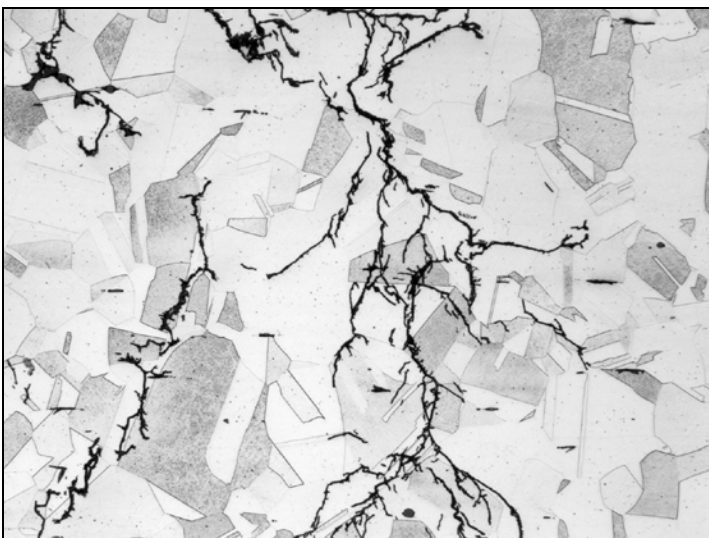
**Photo 5:** Mag: 100X; Etchant: 10% oxalic acid, electrolytic  
Transgranular cracking at the bottom of the pit, viewed at a higher magnification.

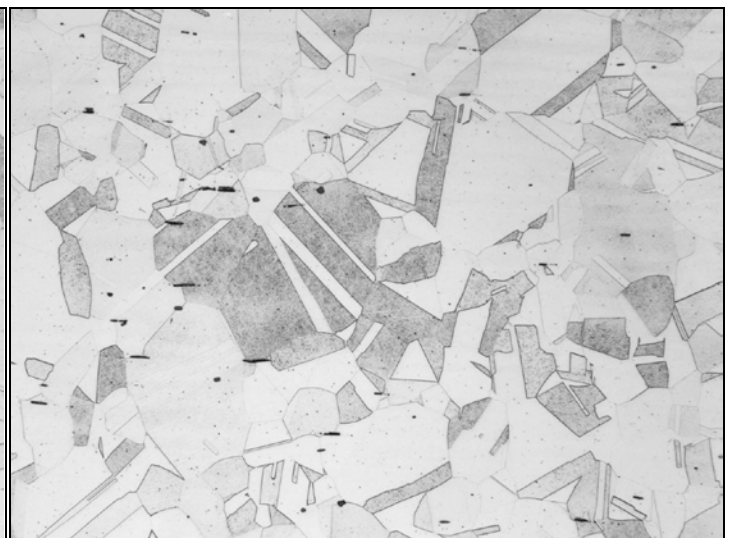
**Photo 6:** Mag: 100X; Etchant: 10% oxalic acid, electrolytic  
A normal austenitic microstructure typical of the base metal.
