## *MSi Investigative Summary*

Two (2) welded stainless steel tube samples removed from a Bottom Circulation (BC) Heater #1 and identified as “failed” and “intact” were submitted to our laboratory for a metallurgical investigation. Reportedly, the failed tube developed cracking after being in service for ~6 months. The intact tube was supplied as a reference. During normal operation the OD surfaces of the tubes had been exposed to saturated steam at ~377°F/190 psia, while the ID surfaces were exposed to a mixture of white and black liquor at ~290°F/280 psia. It was also reported that the BC Heater #1 experienced multiple tube failures, which had occurred roughly at the same location.

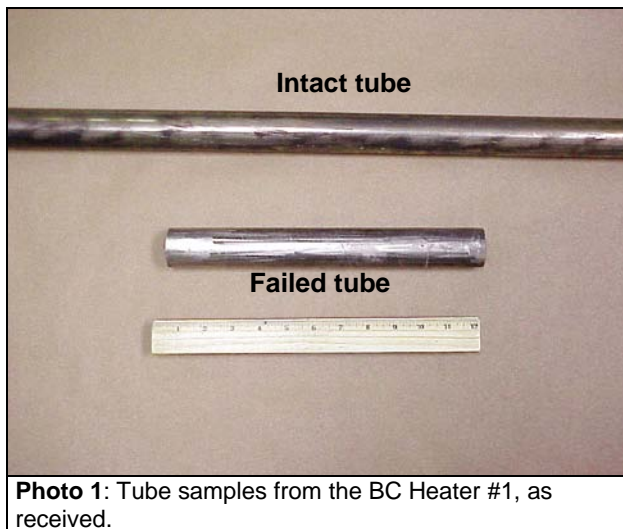
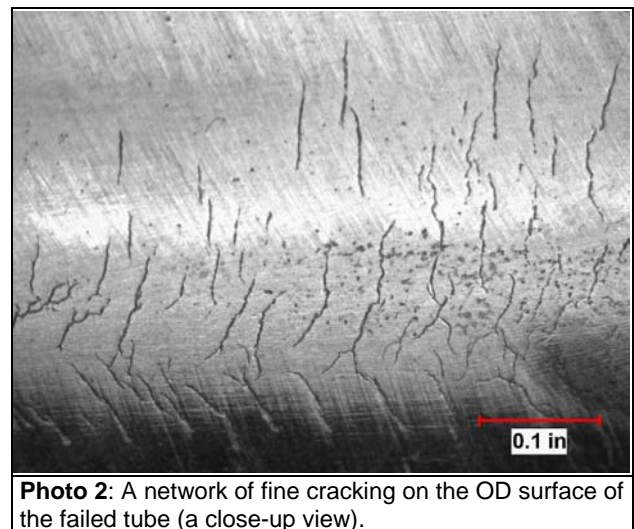
1. Visual and stereoscopic examination of the tubing samples from the BC Heater #1 revealed dark-gray discoloration on the intact tube and evidence of surface polishing on the failed tube (see Photo 1).
2. When viewed at a higher magnification, the OD surface on the failed tube exhibited a network of transverse and oblique cracking (see Photo 2).
3. The failed tube sample was used for metallographic examination, chemical analysis and hardness testing, described in the following sections of this report.
4. The intact tube sample was reserved for mechanical testing described in the following sections of this report.

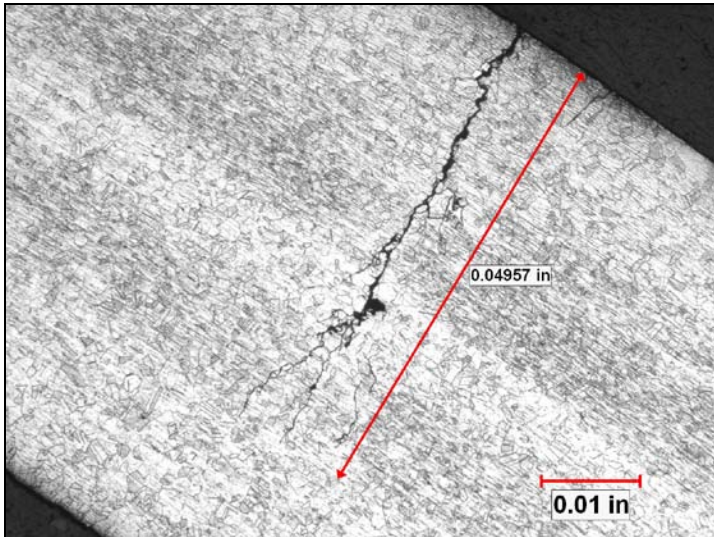
1. Transverse and longitudinal sections removed from the failed tube revealed multiple branching cracks propagating from the OD surface (see Photos 3 – 6 on the following page). Through-wall crack propagation in the examined areas was estimated at ~85%.
2. The mode of cracking was identified primarily as transgranular with occasional evidence of intergranular propagation. The cracks appeared to be uniformly distributed throughout the welded areas and the areas away from the weld. The observed cracking morphology is characteristic of a stress-corrosion cracking (SCC) attack in 300-series stainless steel.
3. SCC failures in 300-series stainless steels occur under exposure to chlorides, bleach or hydrated liquor salts. Identification of the corrosive species directly responsible for the attack could not be performed, since the OD surface of the affected tube had been

**Photo 3:** Mag: 100X Etchant: 10% oxalic acid (electrolytical). Transverse tube section, SCC cracking away from the weld.

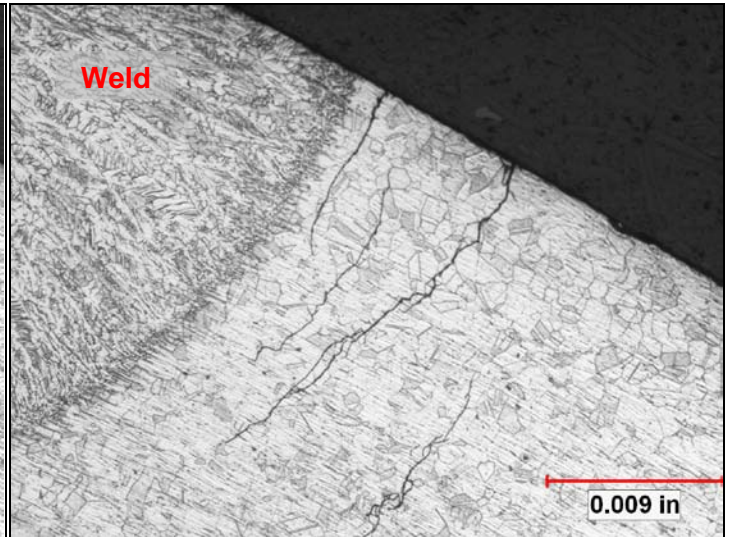
**Photo 4:** Mag: 100X Etchant: 10% oxalic acid (electrolytical). Transverse tube section, SCC cracking near the weld.

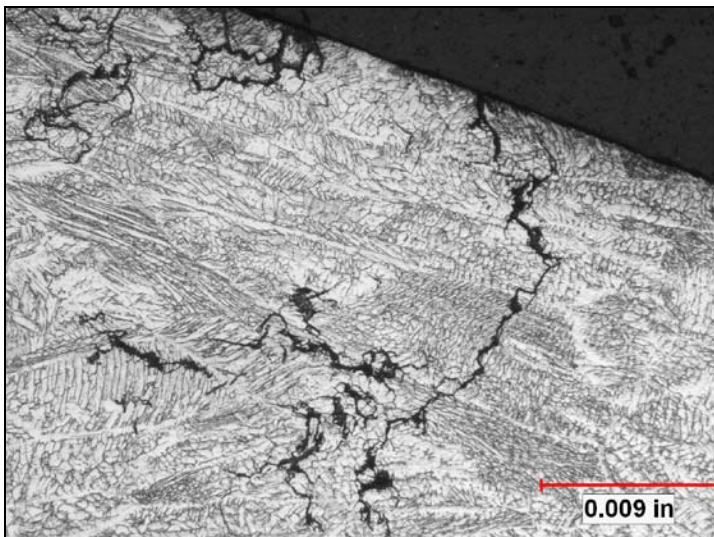
**Photo 5:** Mag: 100X Etchant: 10% oxalic acid (electrolytical). Transverse tube section, SCC cracking in the weld.

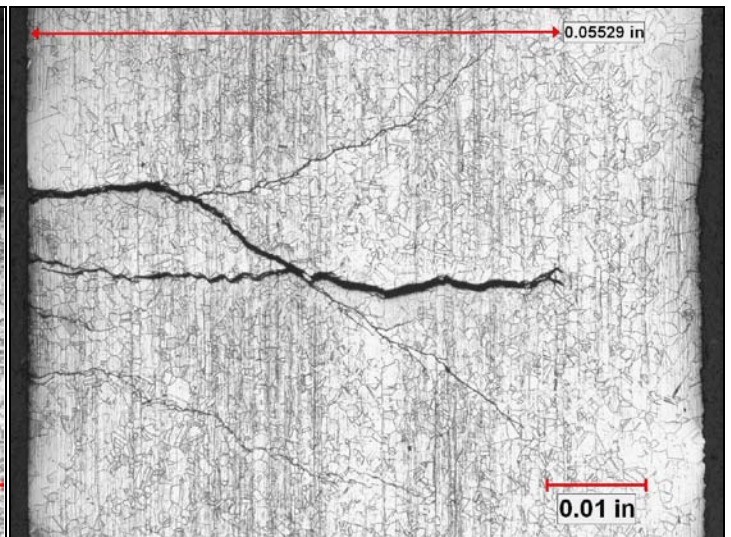
**Photo 6:** Mag: 100X Etchant: 10% oxalic acid (electrolytical). Longitudinal tube section, SCC cracking away from the weld.
