MSi Investigative Summary

Two (2) sections removed from a cast iron cylinder head were submitted to our failure analysis lab for a metallurgical investigation. The submitted sections were identified as Sample #1 and Sample #2. Both samples exhibited sub-surface defects that were exposed during machining or cutting of the wall section. The cylinder head was reportedly poured with gray iron into a green sand mold. Hot box cores were also utilized, which were coated with a water based coating. We were requested to perform a metallurgical failure analysis to determine the nature of the defects and provide the following summary.

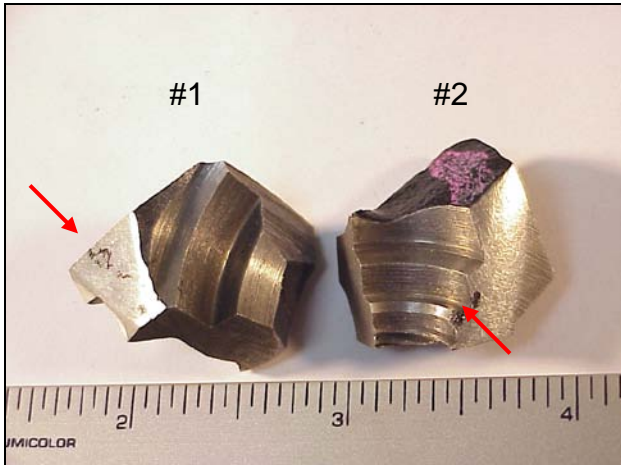
1. Visual and stereoscopic examination of Samples #1 and #2 revealed sub-surface cavities that were irregular and fissure-type in #1 to relatively smooth with an exuded ball of metal at mid-point in Sample #2. (See Photos 1 – 3)
2. The defect profiles in Photos 2 and 3 were sectioned and further examined using metallographic methods.

Photo 1: View of the submitted cylinder head samples #1 and #2. Arrows indicate defect locations

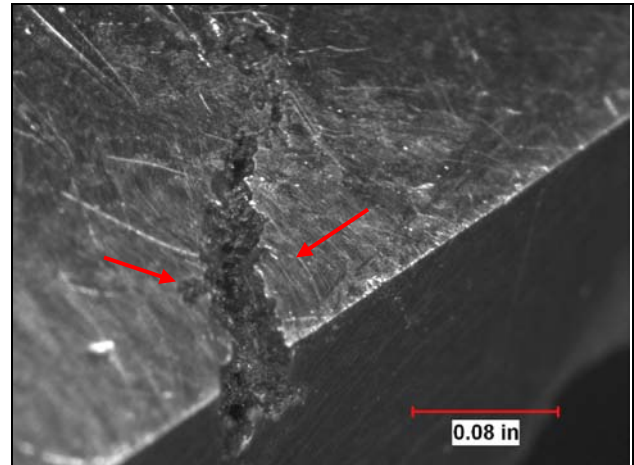
Photo 2: Close-up view of fissure-type defect on sample #1 between arrows. Mag: 15X

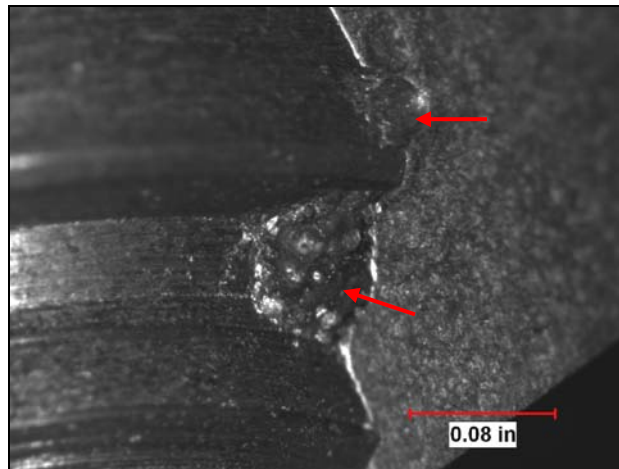
Photo 3: Close-up view of gas-type defect on sample #2, which included a smooth surface and exudation of metal near mid-point. See Arrows. Mag: 15X

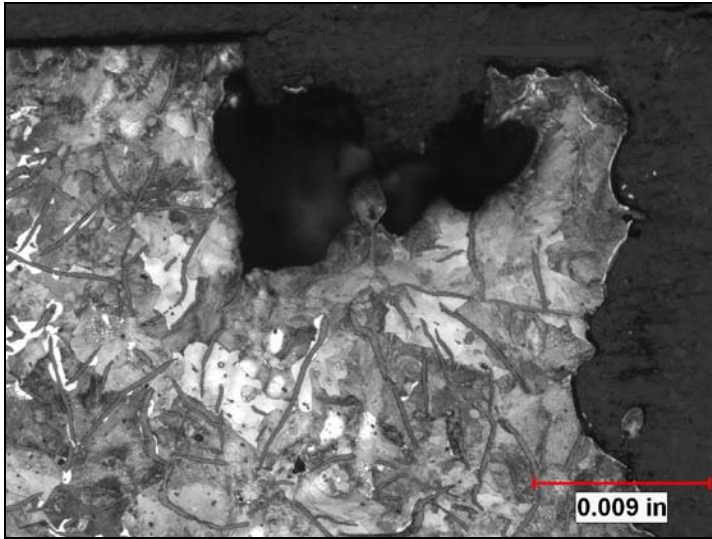
1. Examination of the two defect profiles verified the fissure-type conditions of Sample #1 and the relatively smooth surface and exuded ball of metal in Sample #2. Both were partially lined with a discontinuous layer plus graphite flakes in the matrix extended into the cavities, which is characteristic of nitrogen related gas porosity. (See Photos 4 – 7)

Photo 4: Mag: 100X; Etchant: 3% Nital
Sample #1: Defect profile was irregular and fissure-type

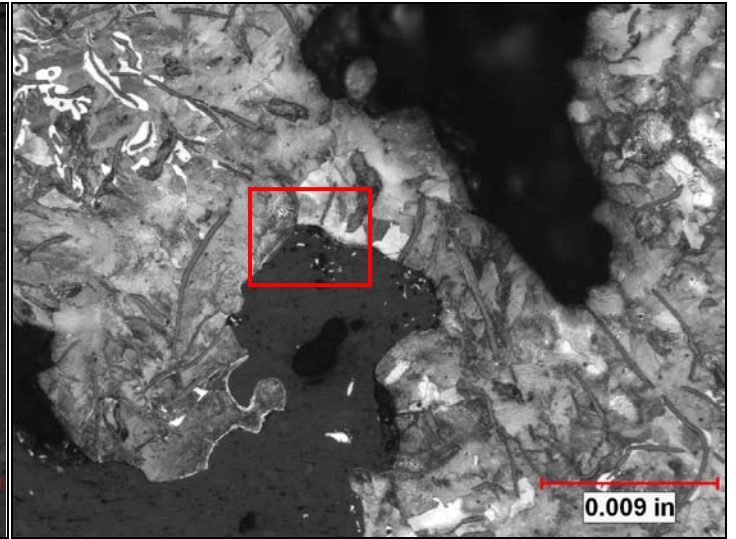
Photo 5: Mag: 100X; Etchant: 3% Nital
Sample #1: Defect profile lined with discontinuous layer.

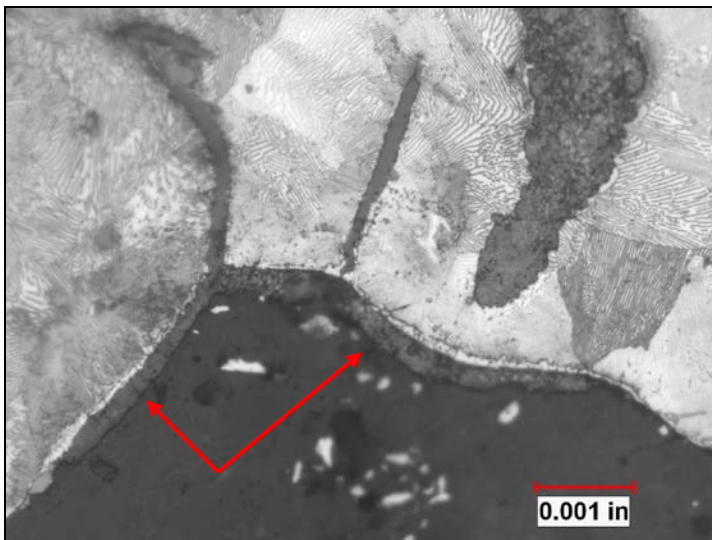
2. The microstructure of the two sections consisted of fine pearlite and small amounts of ferrite, which was characteristic of Class 30 or Class 35 gray iron. (See Photo 6)

Photo 6: Mag: 500X; Etchant: 3% Nital
Close-up view of inset in Photo 5 showing a layer lining the defect.

3. The discontinuous layer of material lining the defect profiles as seen in Photos 6 and 7 was subjected to EDS analysis.

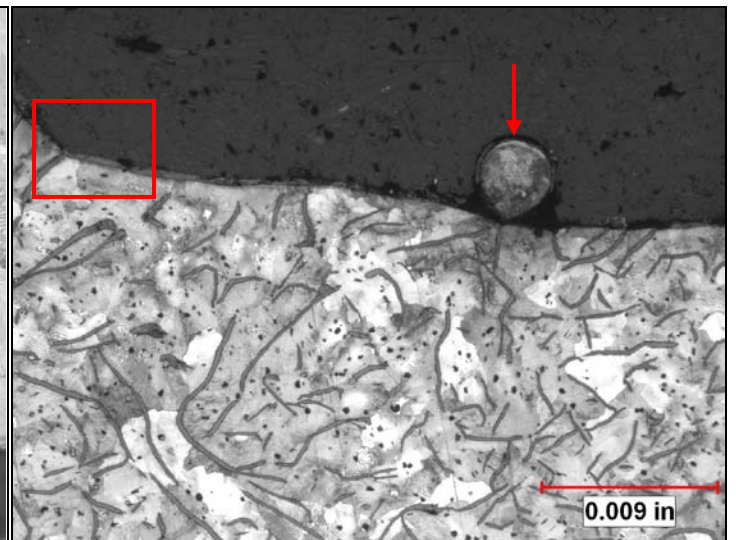
Photo 7: Mag: 100X; Etchant: 3% Nital
Sample #2: Exuded metal ball at midpoint of defect.

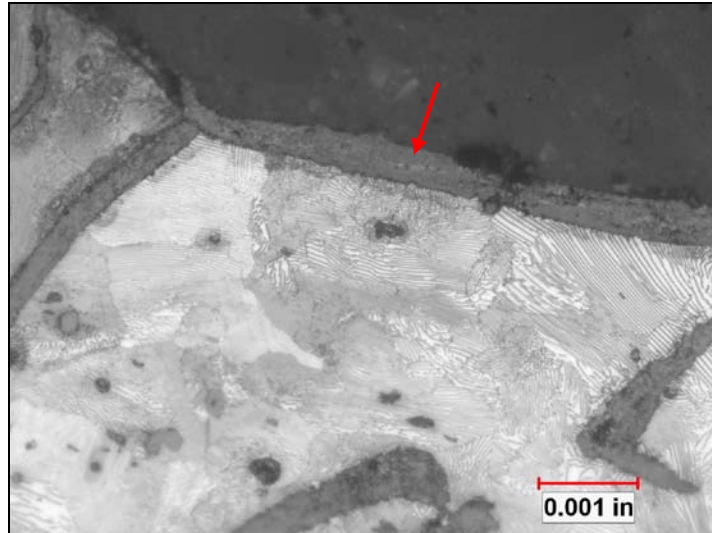
Photo 8: Mag: 500X; Etchant: 3% Nital
Close-up view of inset in Photo 7 showing layer lining the defect.

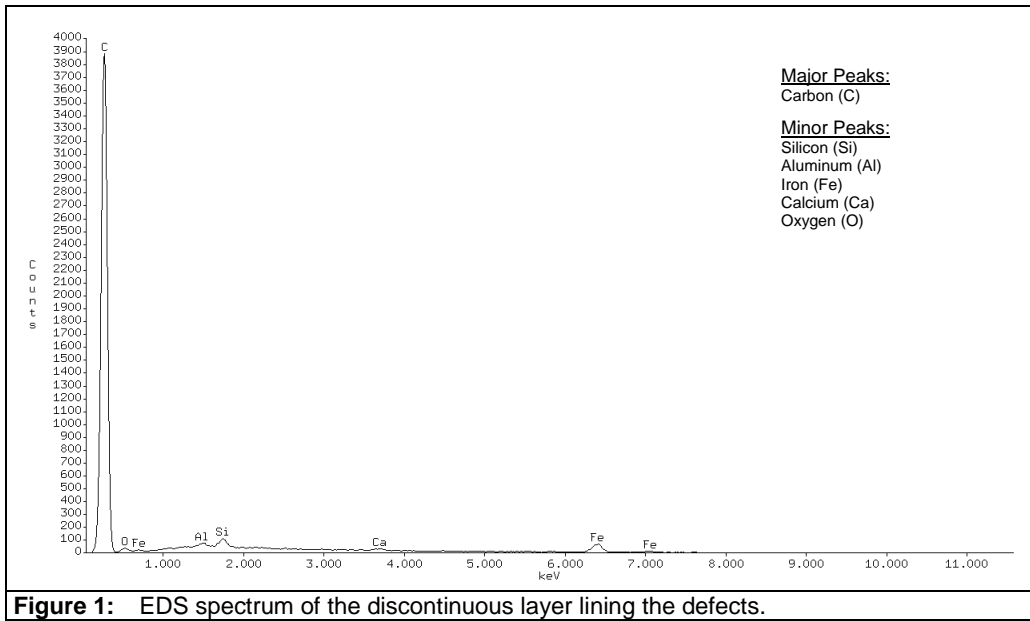
1. EDS analysis of the discontinuous layer lining the defects revealed a major elemental peak of carbon and minor elemental peaks of for silicon, aluminum, iron, calcium, and oxygen. The results indicate the layer was primarily graphite (carbon), which is a common characteristic of a gas cavity formed from nitrogen gas.
2. See attached Figure 1.

Figure 1: EDS spectrum of the discontinuous layer lining the defects.

3. The nitrogen content of the iron was 70 ppm, which was within a normal range. However, the titanium content of the iron was only .006%. We respectively recommend the use of a graphitizing inoculant containing a substantial amount of titanium, approximately 9.5%. Proper use will result in titanium levels of .02 – .04%, which will combine with excessive nitrogen to form titanium nitrides and minimize porosity from nitrogen gas.
