“A small surface indication exposed by a machining operation was not a material defect as determined by failure analysis service performed by MSi Testing & engineering.’

MSi Investigative Summary

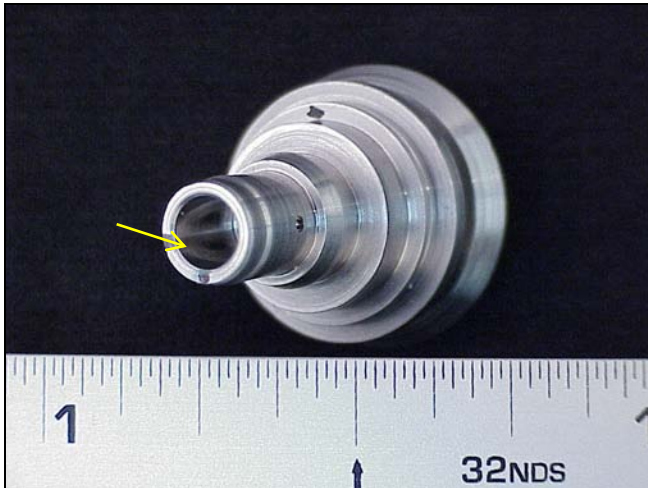
1. SEM examination of the ID surface revealed a faint, intermittent, linear surface defect indication along the .234" diameter ID surface. (See arrows in Photos 1 - 2).
2. Examination at higher magnification showed evidence of disturbed metal, most likely from the machining tool (see Photos 3 - 4). No evidence was observed of a pre-existing internal steel defect or inclusion stringer on the ID surface.

Photo 1: Submitted part with surface defect indication on the ID surface, denoted by the yellow arrow. 1.5X

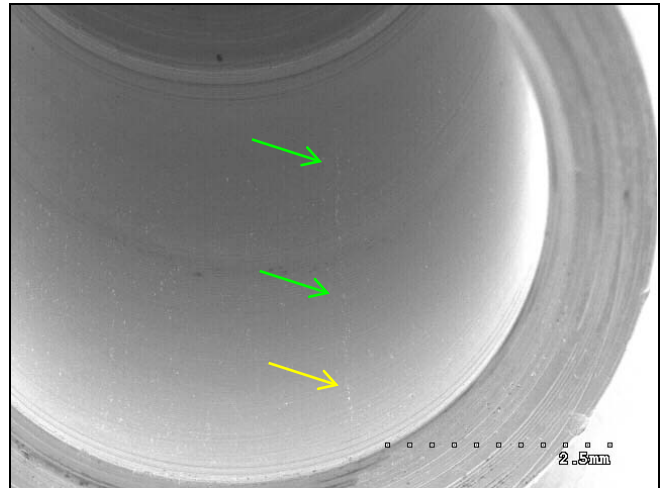
Photo 2: SEM image showing the faint linear defect indication on the machined ID surface. 10X

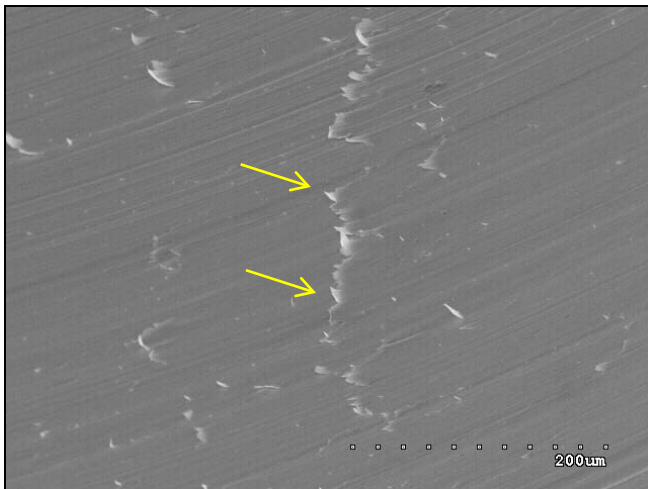
Photo 3: Close-up view of linear defect indication denoted by the yellow arrow in Photo 2. 165X

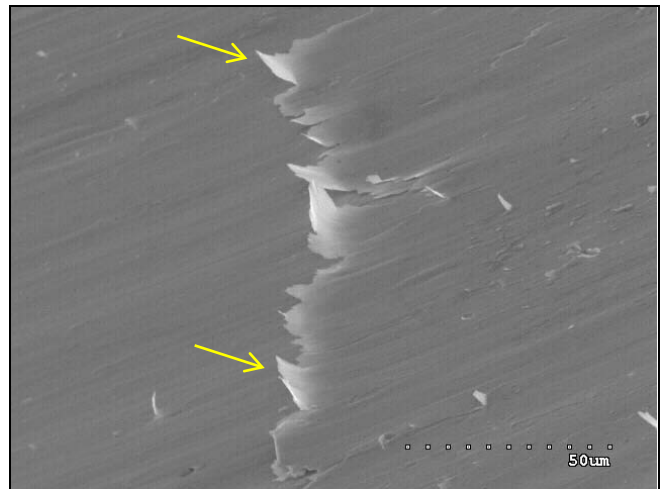
Photo 4: Higher magnification view of Photo 3 showing a tool mark from the machining operation. 1350X

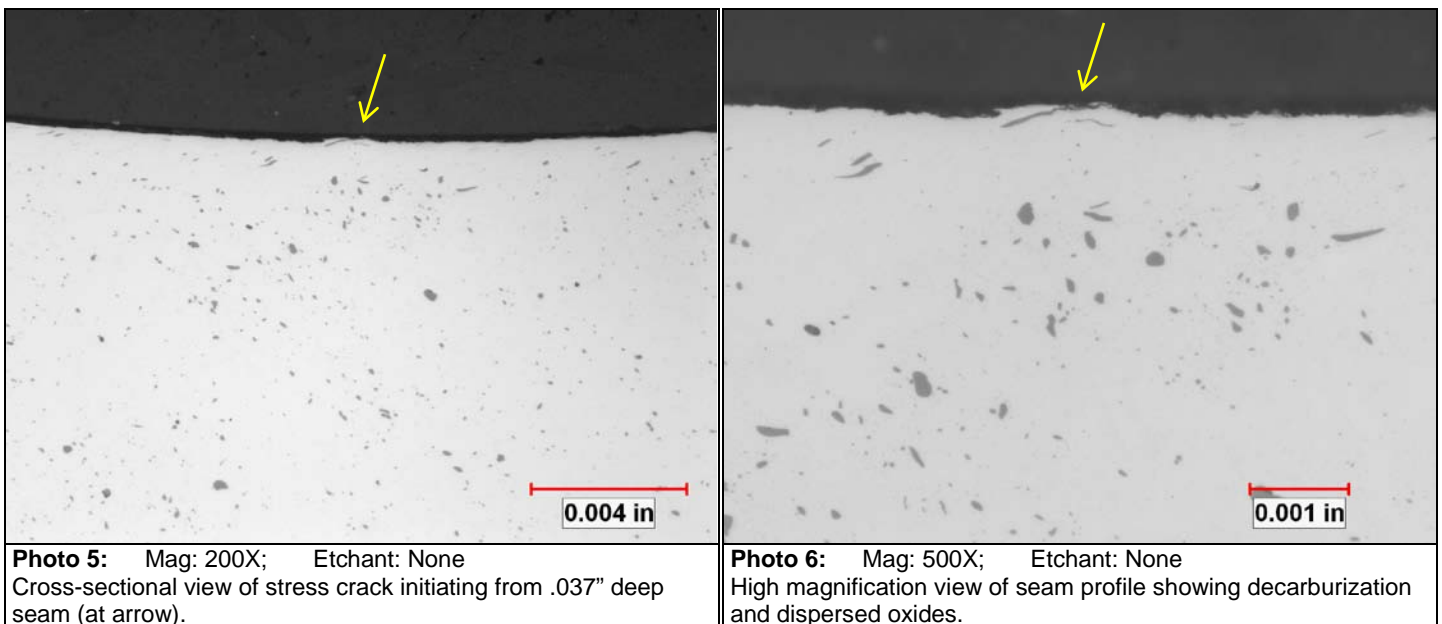
1. A transverse section removed from the region containing the ID surface defect indication confirmed the presence of a tool mark that was induced during the machining operation. (See arrow in Photos 5 - 6)
2. No evidence was observed of an abnormal inclusion content or any other detrimental internal conditions that could have caused the defect indication.
3. The microstructure consisted of pearlite and grain boundary cementite in a matrix of ferrite, typical of AISI 1215 steel.
